Volume 18, Number 3

CH2M HILL

Emergency canal repair saves crops

CRITICAL WATER SUPPLY RESTORED TO IRRIGATION DISTRICT

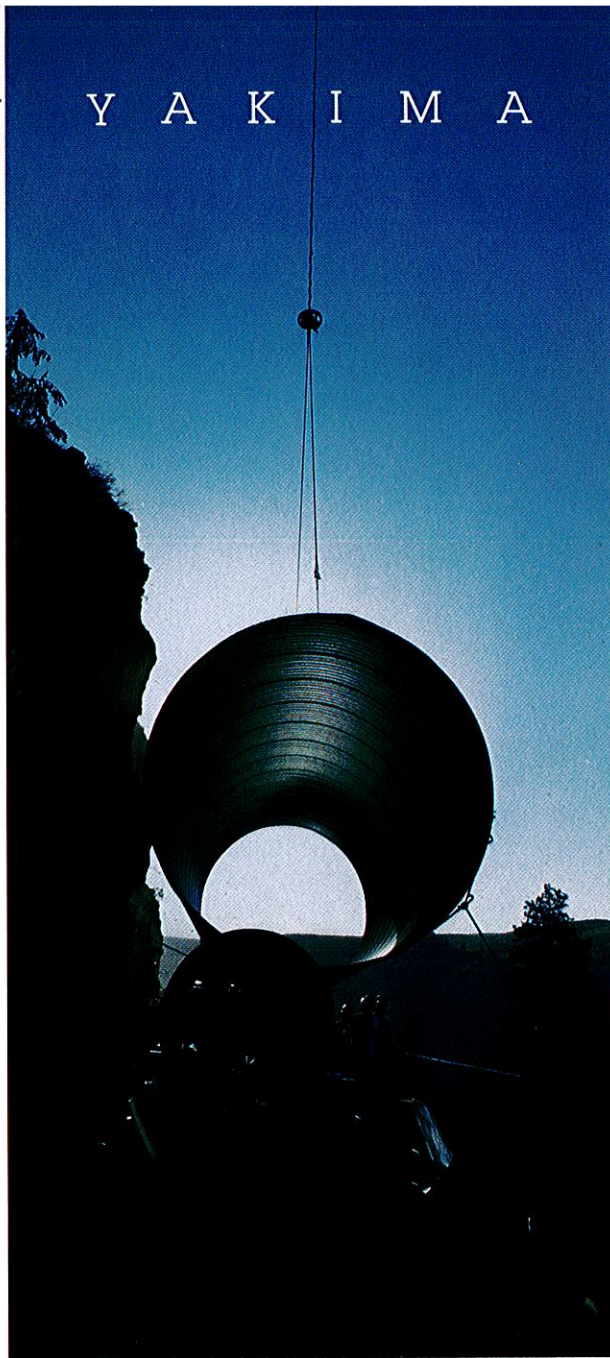
The crisis occurred about 400 feet up a nearly vertical cliff, where a 100-foot-long section of a concrete irrigation canal had collapsed. This canal is the sole source of water for 26,000 acres of fruit trees. If not restored to operation within three weeks, serious damage to the crops could result.
