**Pipelines
In
Adverse
Environments
II**

Case Histories:
Construction on Canyon Wall Terrain

By
Frank W. Pita, P.E., P.G., AM ASCE¹
and
B. Louise Woodward, C.E.T.²

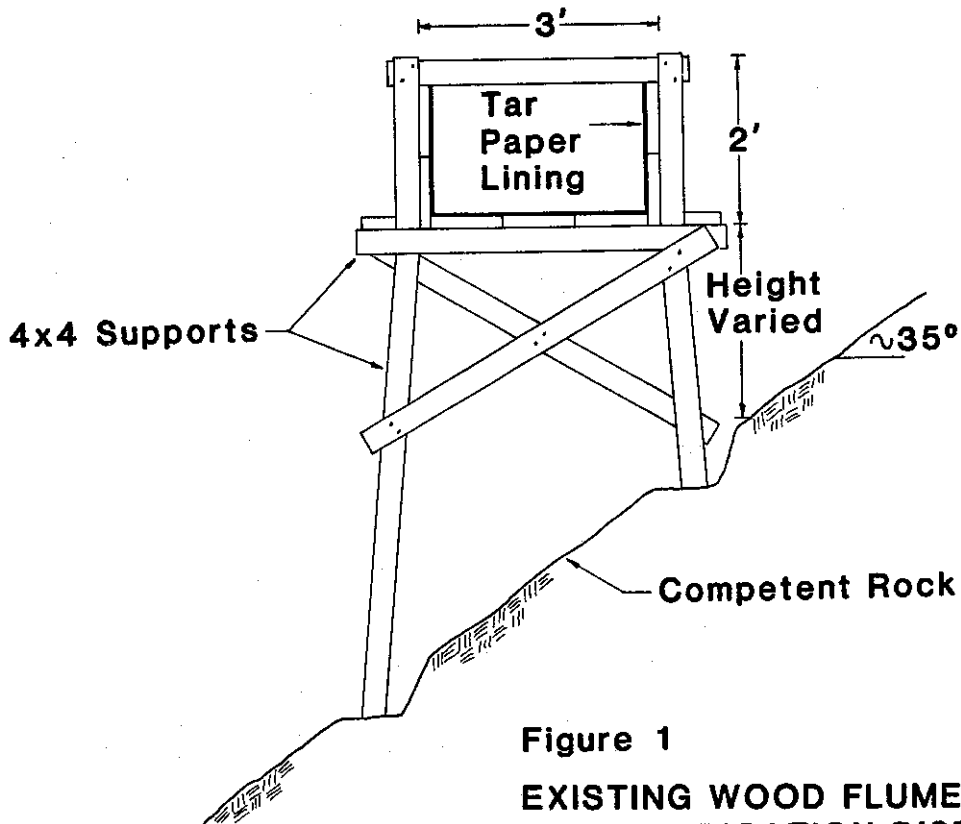
Figure 1
EXISTING WOOD FLUME
ICICLE IRRIGATION DISTRICT

The project location is on the northern valley wall above the Wenatchee River near the City of Dryden, Washington. The site is approximately 400 feet above the valley floor on an exposed sandstone rock slope dipping at a 35° angle. Figure 1 is a cross-section showing the wooden flume that was replaced by 1550 feet of elevated steel pipe. The flume had required continual maintenance and was in danger of imminent failure. The design of the replacement pipe was tailored for small helicopter installation and working with hand tools. Because of previous small rock falls and winter avalanches the pipe is elevated above the rock face so that slides can pass beneath the pipe without damage. Figure 2 shows a typical fitting and column support for the 30-inch diameter spiral-weld steel pipe. The supports range in height from 2-feet to 15-feet and are positioned at 30-foot intervals. Custom-designed concrete footings with rock anchors allow for irregular rock formations and varying grades of steepness on the face of the cliff. The steel supports were bolted down to ensure a solid foundation for the pipeline.

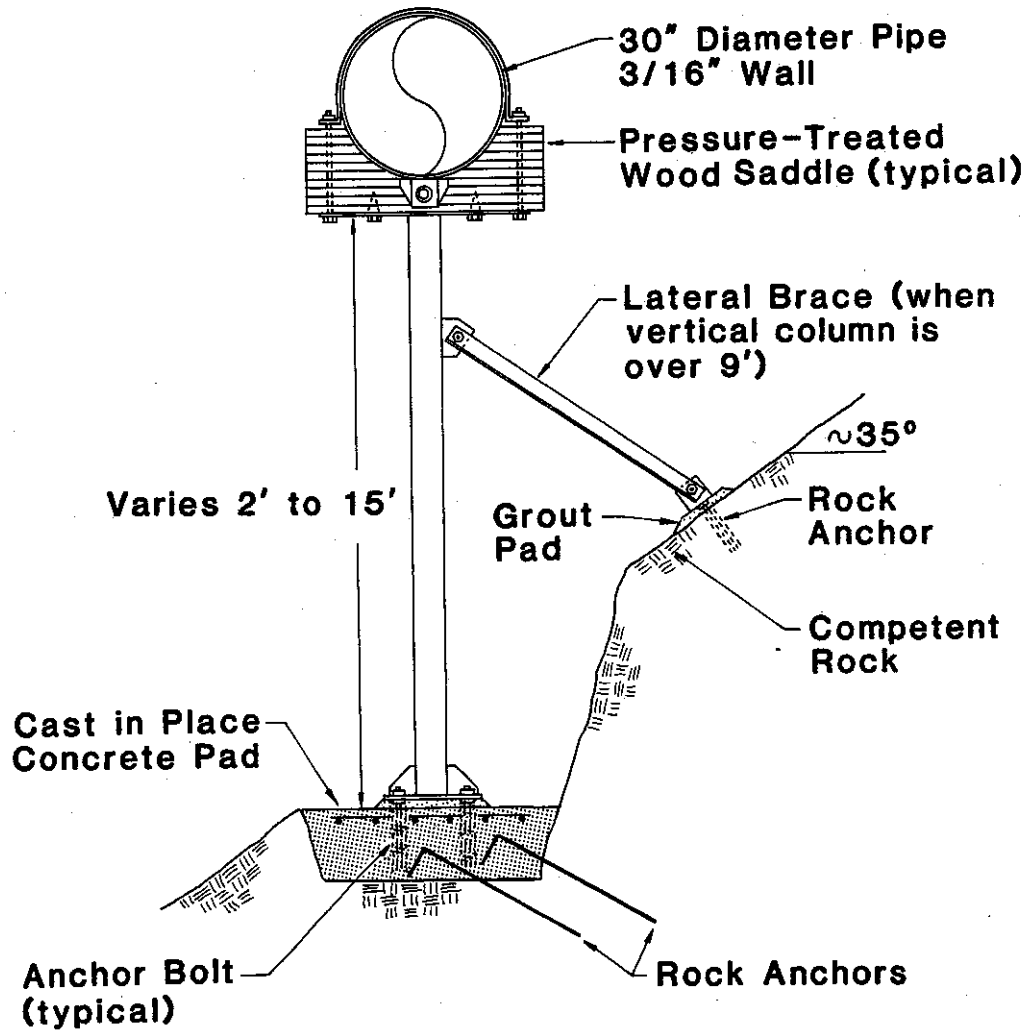
Figure 2
TYPICAL PIPE SUPPORT
ICICLE IRRIGATION DISTRICT

Note:
Support spacing at 30' interval.

The base plates of the steel supports were adjustable, and mortar was hand placed beneath the plate after final alignment of the entire pipeline. Significant savings were made by limiting the weight of the sections to 1800 pounds so that a small, locally based helicopter could be used for lifting and placing them. All of the prefabricated metal pieces were moved and set in place by helicopter as were three-quarter yard concrete buckets used for placing the concrete footings. The pipe sections were connected by using compression collars which were hand-placed and tightened. No field welding was performed on the pipe. Exact fabrication and field surveying were key elements in the success of the project.

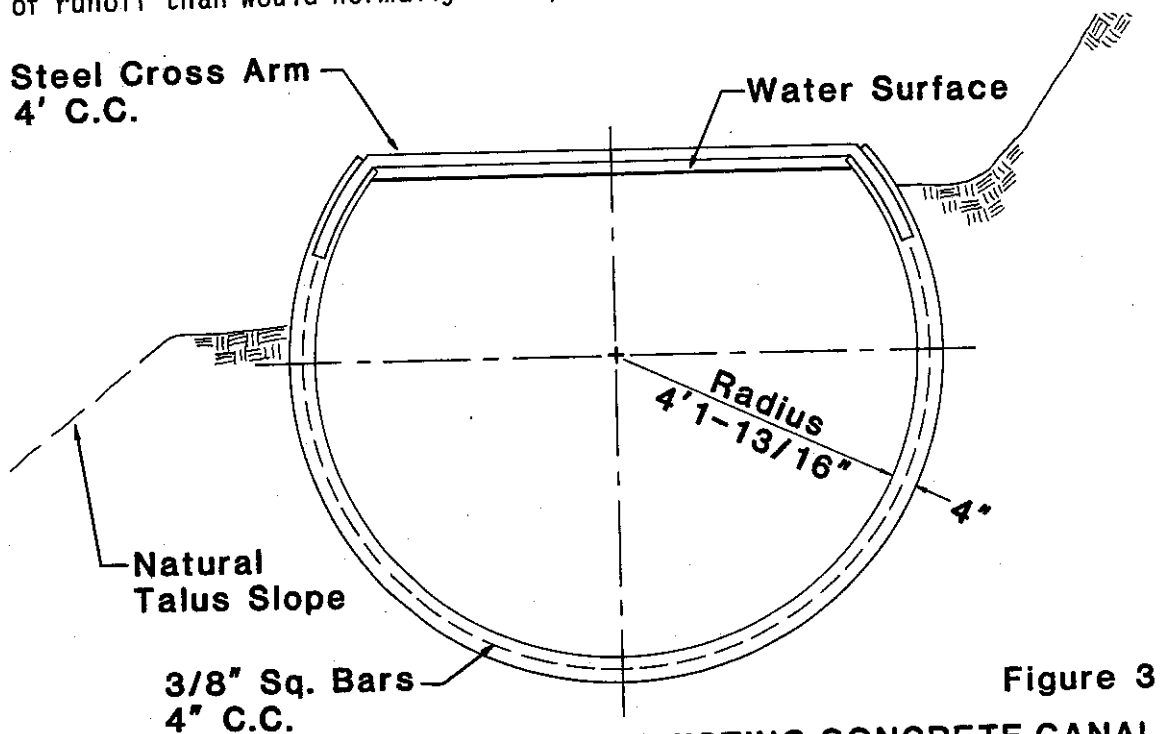
Figure 3
EXISTING CONCRETE CANAL
YAKIMA-TIETON IRRIGATION DISTRICT

The most severe damage occurred between canal-mile 9.13 and 9.15, where the overtopping eroded the loose talus slope on the downhill side of the canal, undermining a portion of the flume. A section approximately 100-feet long collapsed and the continued flow of water from upstream caused further erosion, resulting in a 300-foot wide by 100-foot deep plunge pool basin carved immediately below the flume alignment (Figure 4). At the canal level, the loose talus had not been eroded under the remaining exposed ends of the broken flume, although a 40-foot wide area where the water exited the upstream end of the old flume had been eroded down to bedrock. The bottom of the plunge pool area (approximately 100 feet below canal level) was relatively flat and the talus side walls were vertical and even undercut in some areas. Nearer to the valley floor (river level) the basin narrowed into a gully clogged with eroded talus rock. The broken remains of the collapsed 100 feet of flume were scattered and intermixed with trees and other debris down the slide area.
